**ESKIMO V
MAGAZINE SEPARATION TEST**

by
F. H. Weals
and
Bill Finder
Test and Evaluation Directorate

FEBRUARY 1979

**NAVAL WEAPONS CENTER
CHINA LAKE, CALIFORNIA 93555**

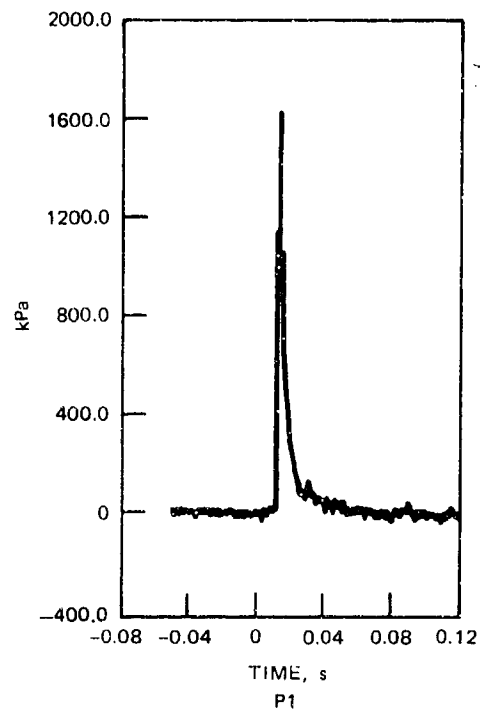
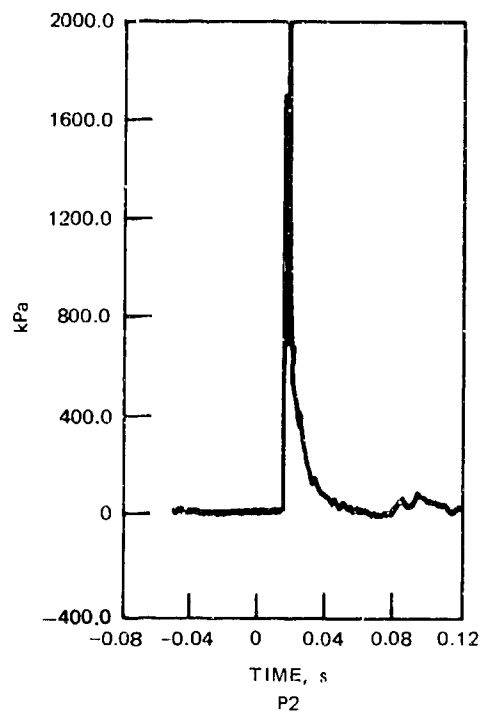
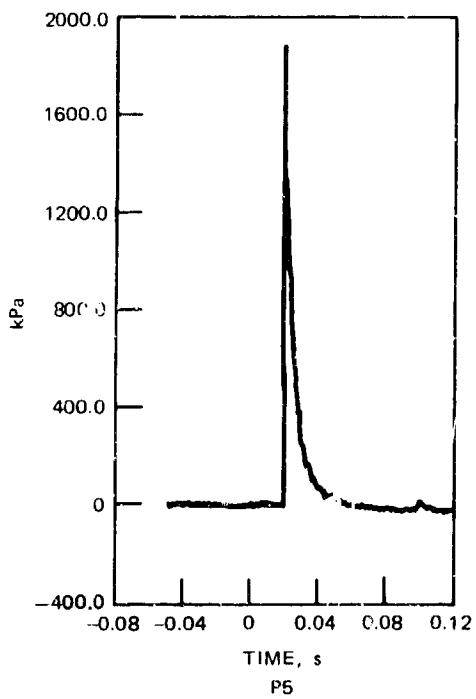
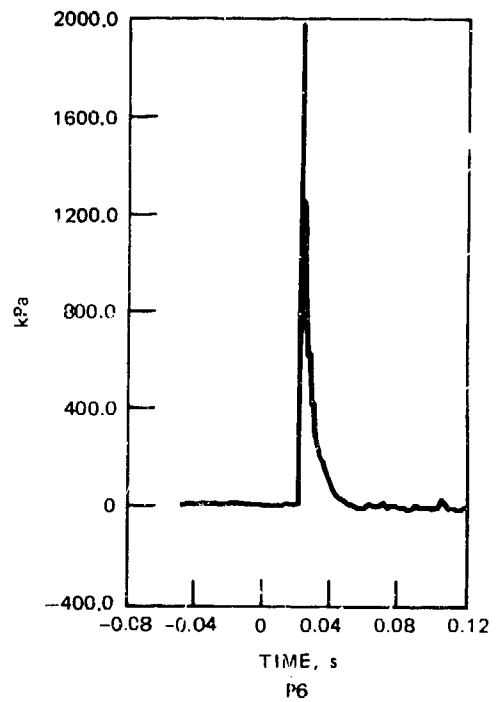
FIGURE 41. Overpressure Gauges P1, P2, P5, and P6, Igloo A.

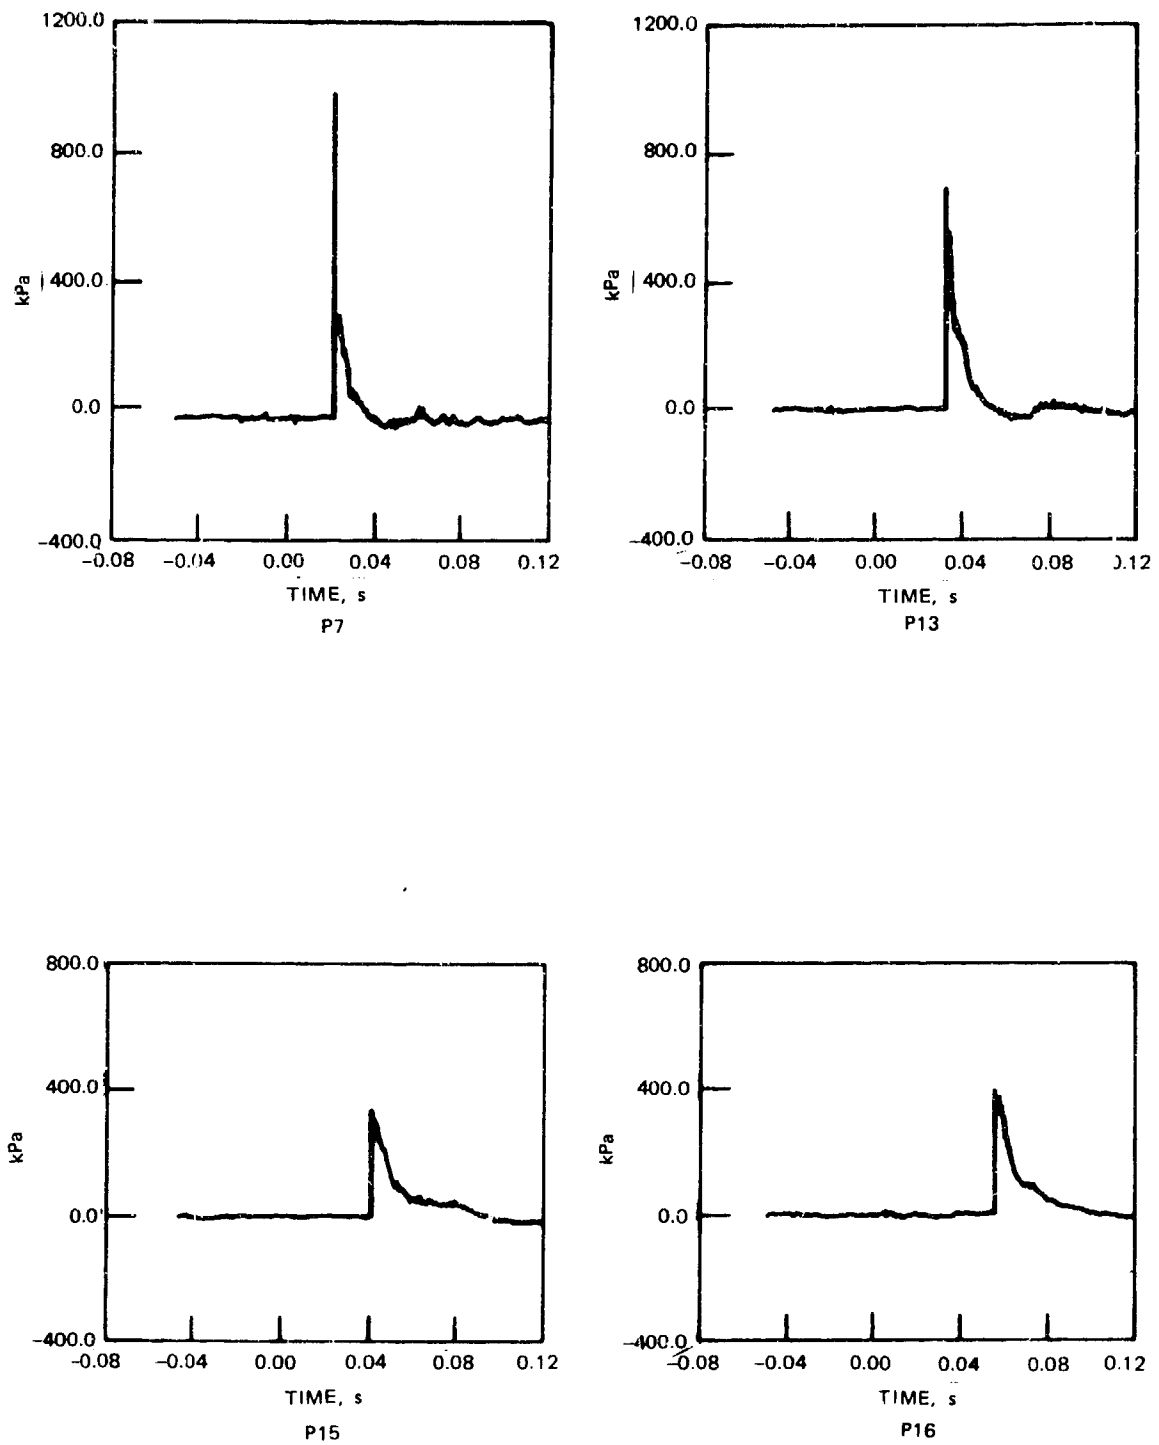
FIGURE 42. Overpressure Gauges P7, P13, P15, and P16, Igloo A.

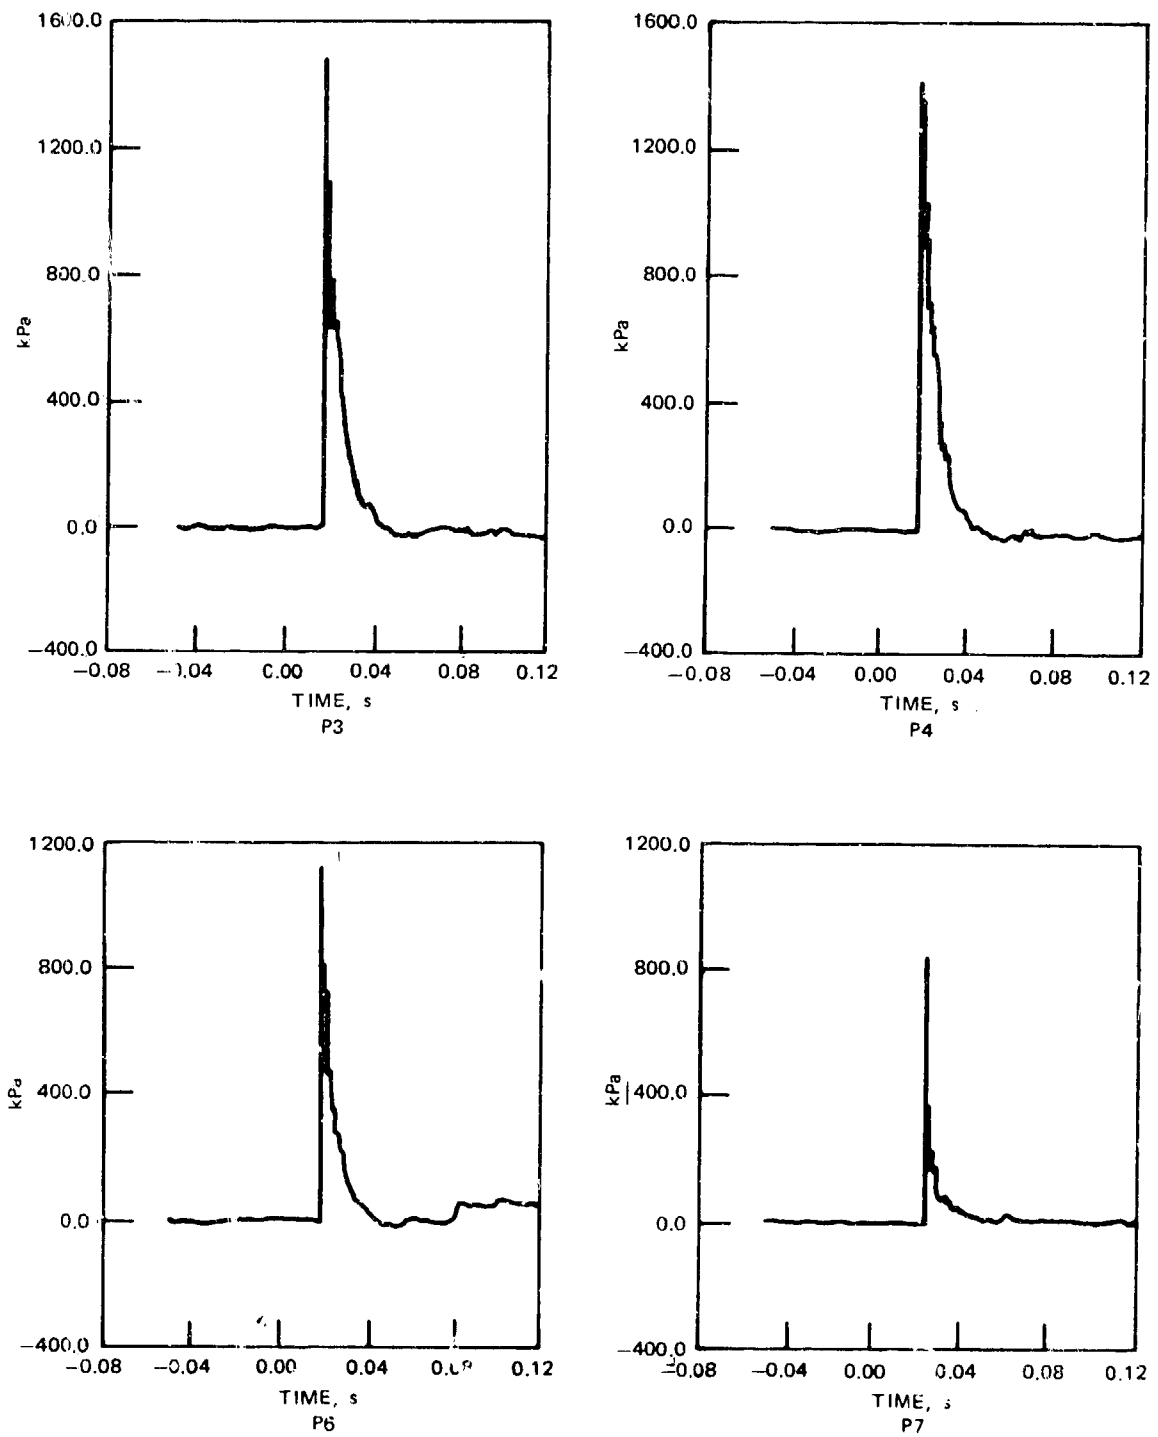
FIGURE 43. Overpressure Gauges P3, P4, P6, and P7, Igloo B.

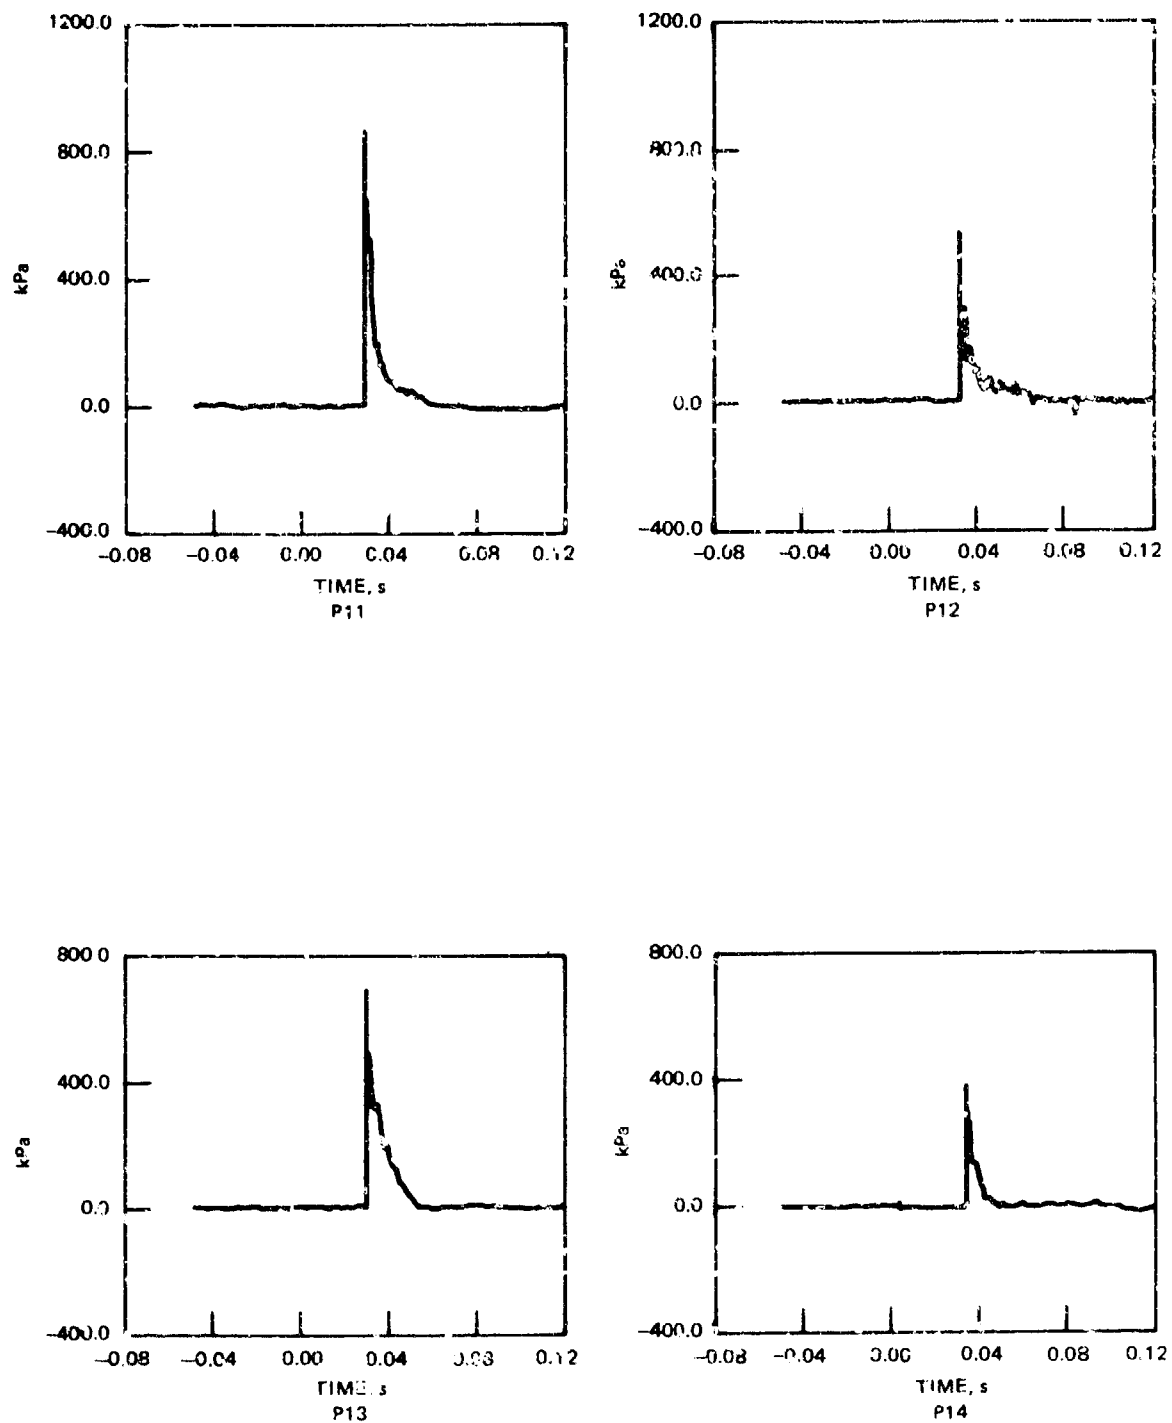
FIGURE 44. Overpressure Gauges P11, P12, P13, and P14, Igloo B.

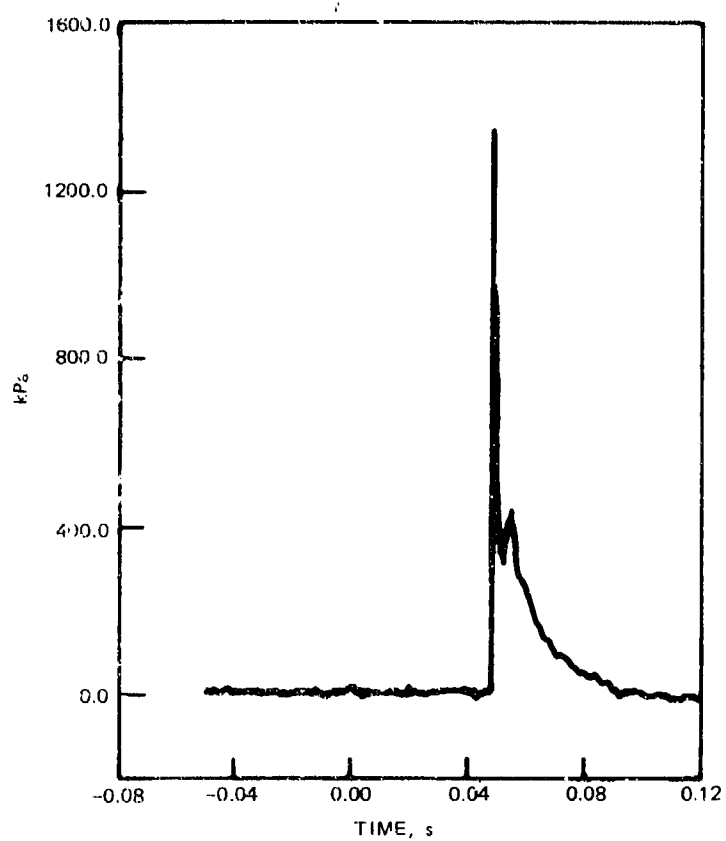
FIGURE 45, Overpressure Gauge P18, Igloo B.

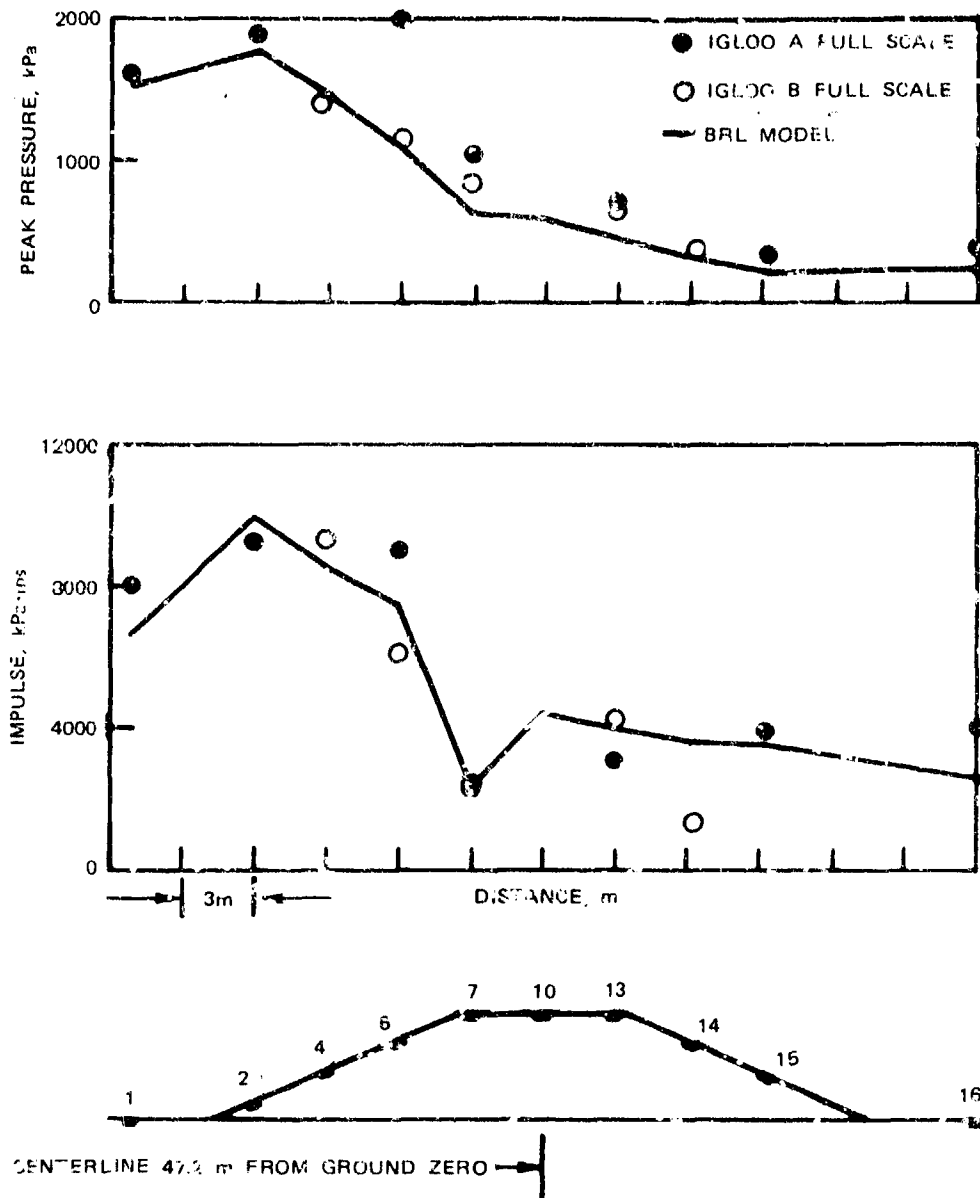
FIGURE 46. Comparison Between BRL Model Predictions and Actual Full-Scale Results.

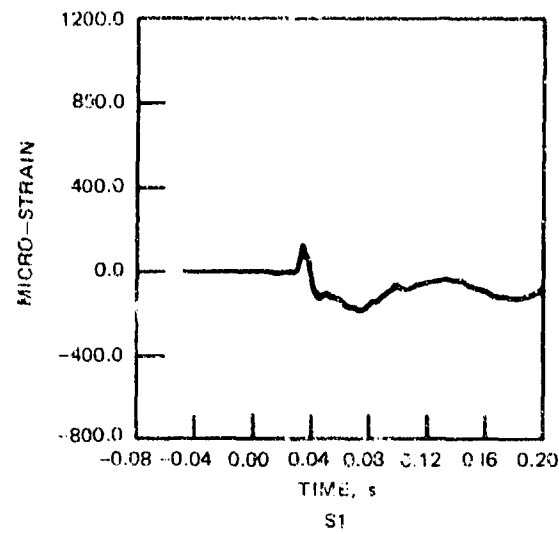
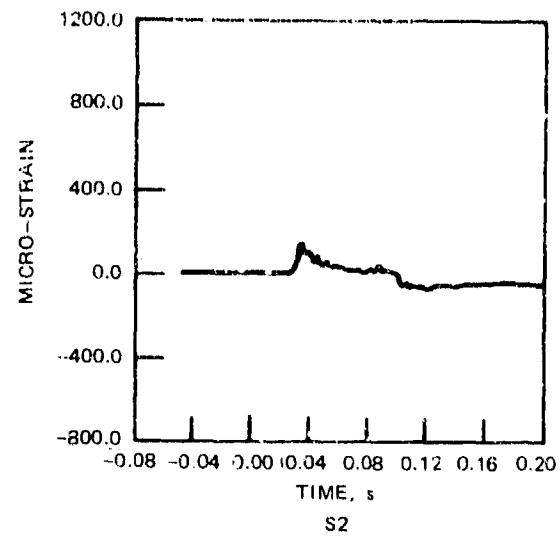
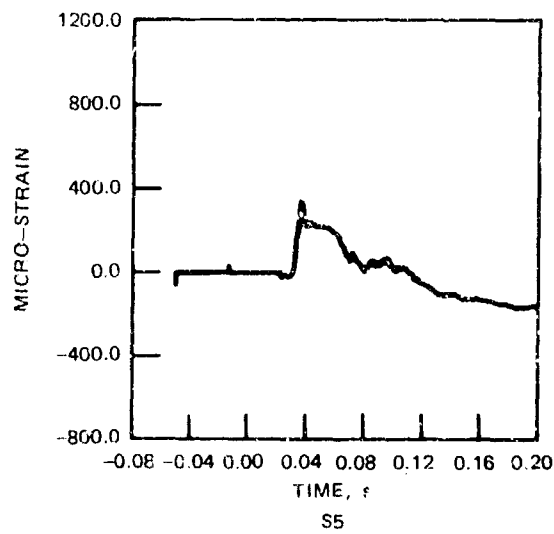
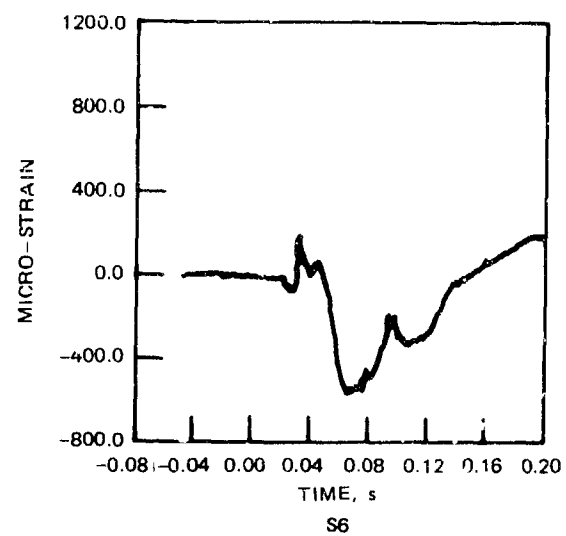
FIGURE 47. Data Plots for Strain Gauges S1, S2, S5, and S6.

Electronic strain gauges were attached to the steel reinforcing bar of the FRELOC magazine at several locations (see Figures 19 and 21). Several of the gauges failed to operate properly, and data on others were of questionable value. A possible reason for this may have been damage incurred during the concrete pour. A summary of strain-gauge data appears in Table 7. Figures 47 through 48 provide graphic displays of that data.

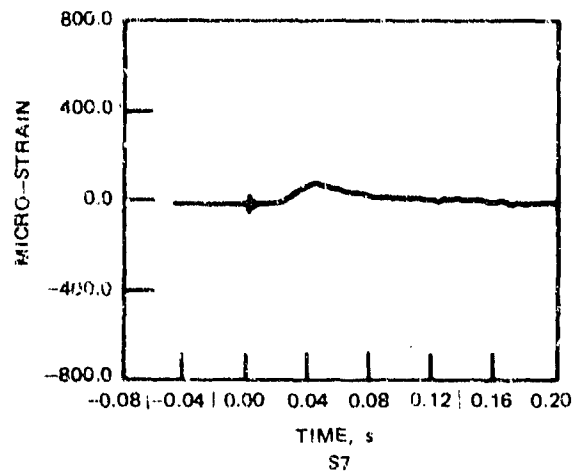
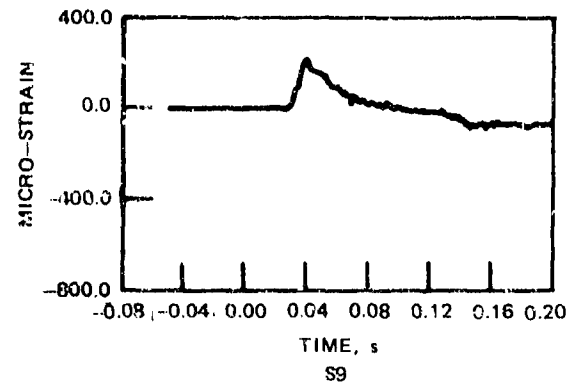
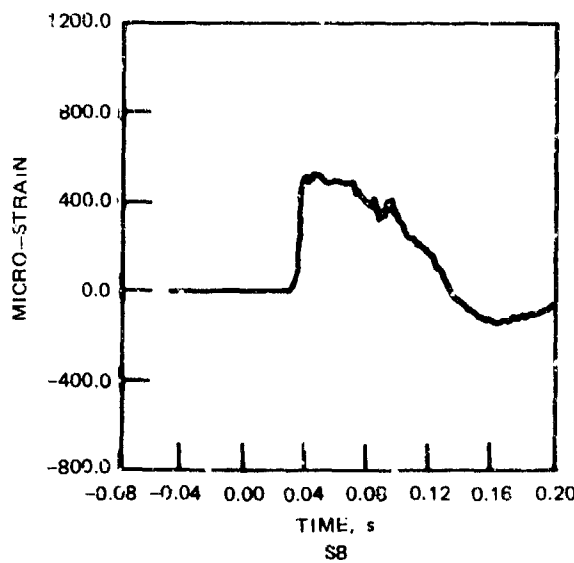
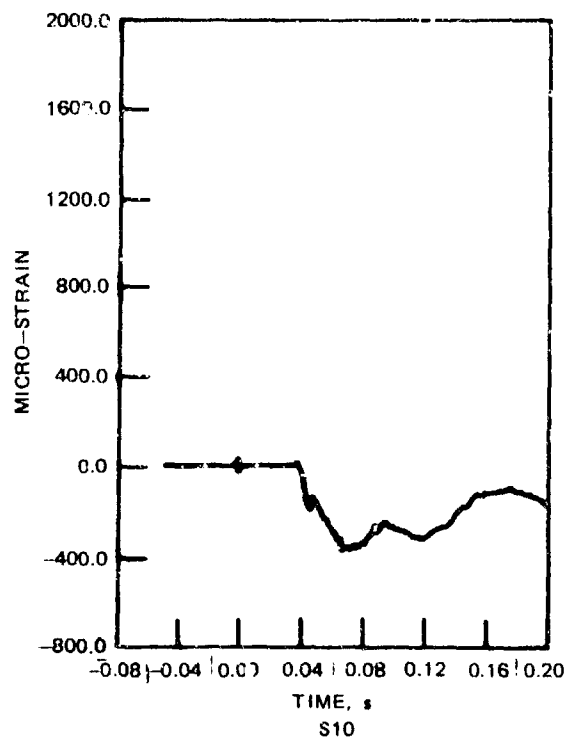
FIGURE 48. Data Plots for Strain Gauges S7, S8, S9, and S10.

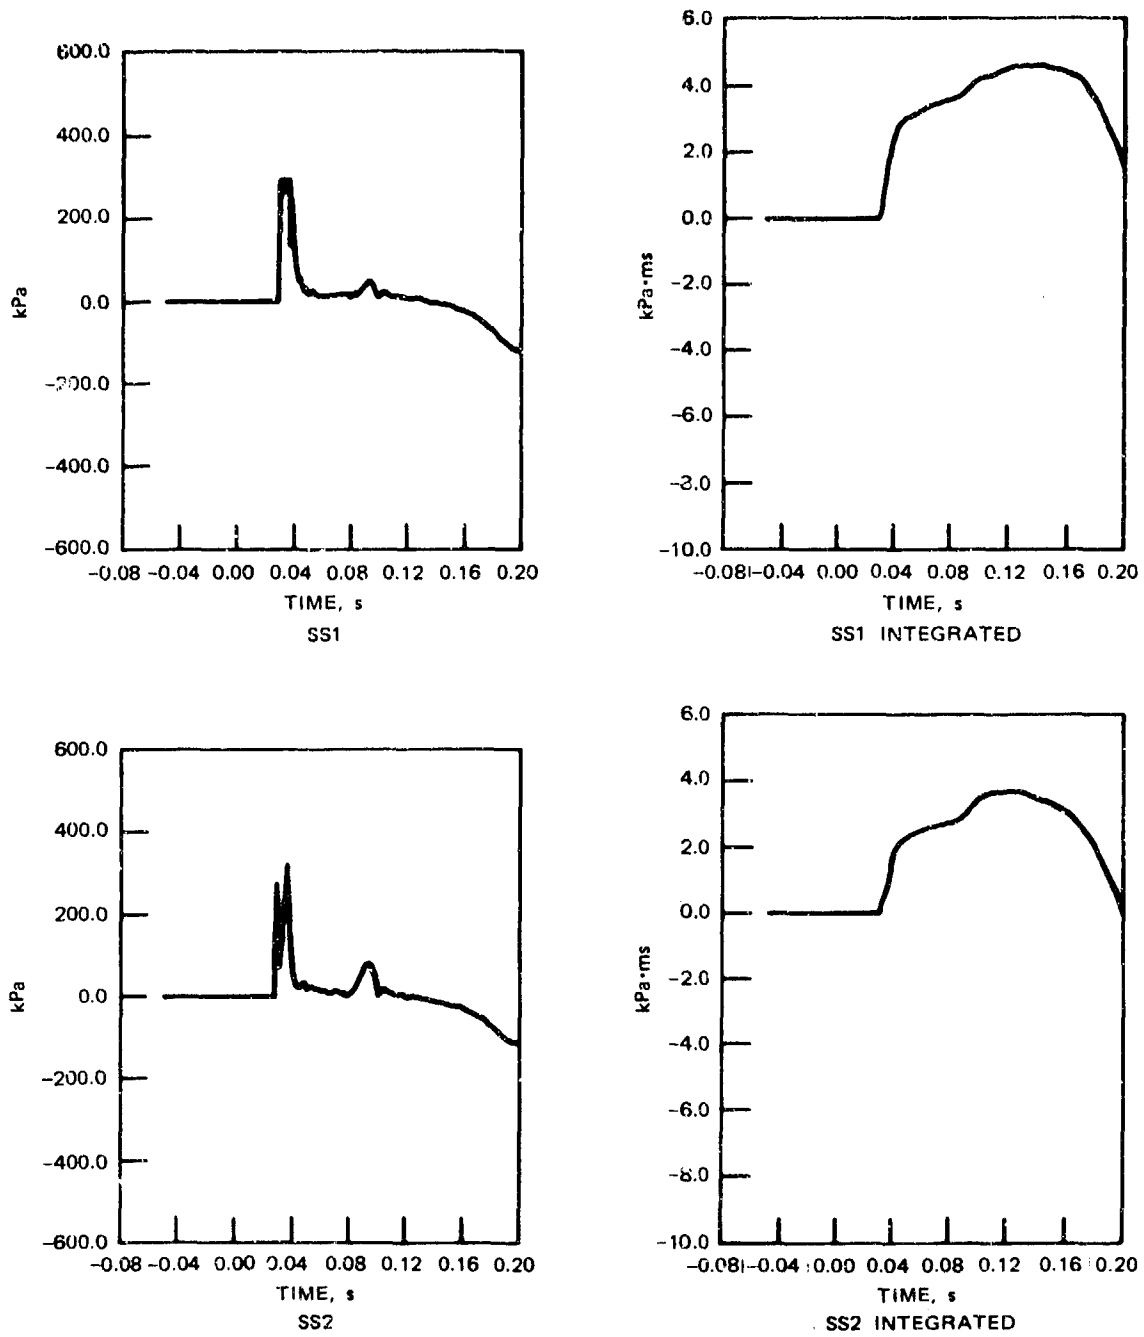
FIGURE 49. Data Plots for Soil-Stress Gauges SS1 and SS2.

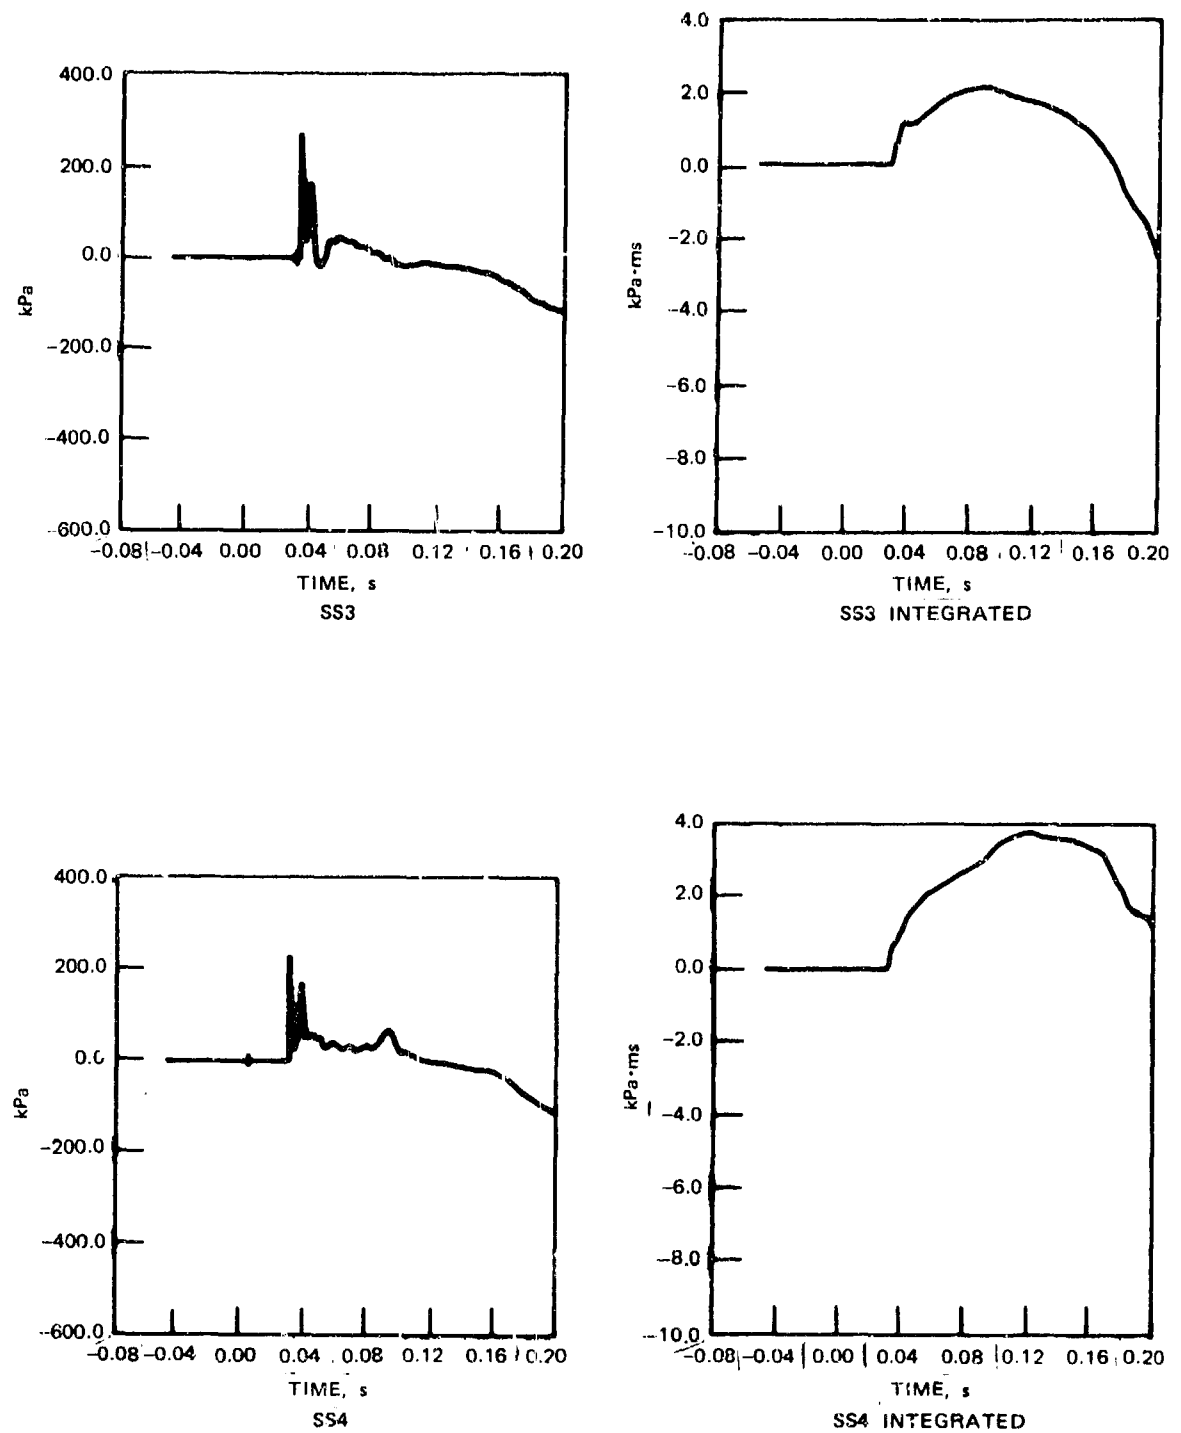
FIGURE 50. Data Plots for Soil-Stress Gauges SS3 and SS4.

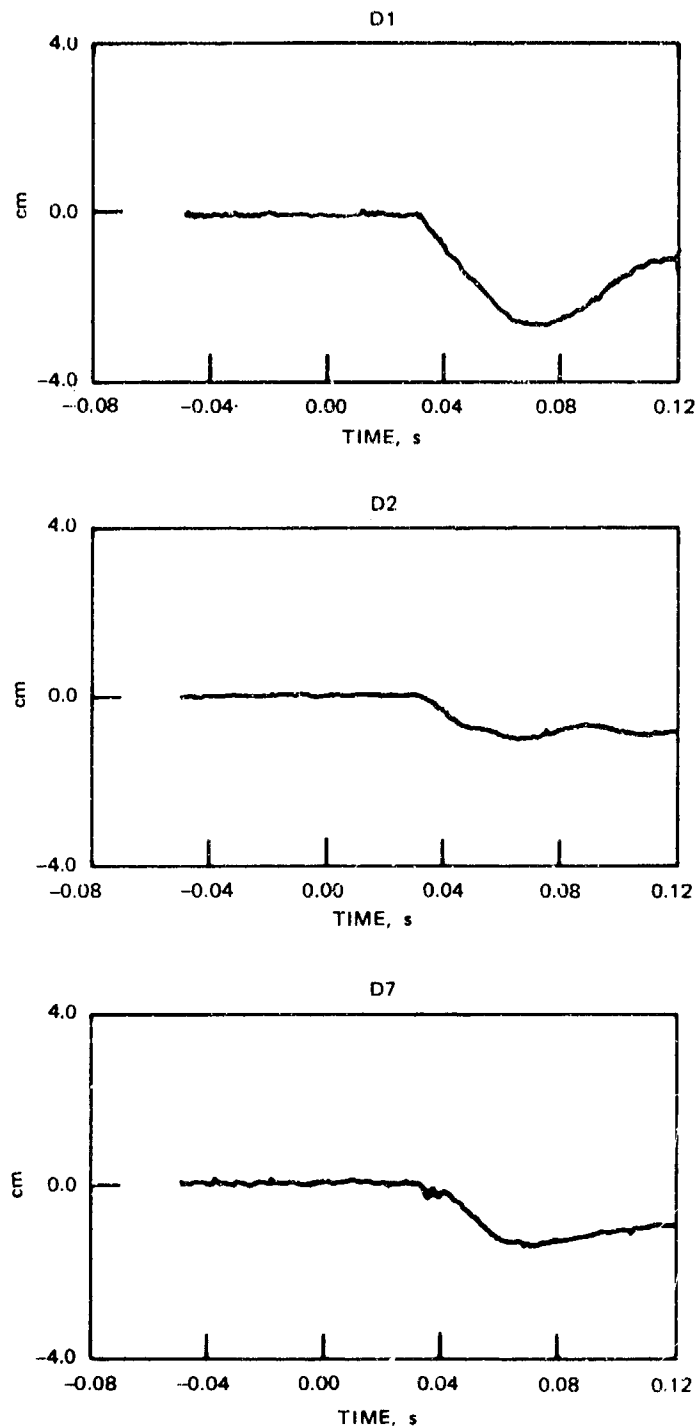
FIGURE 51. Data Plots for Deflection Gauges D1, D2, and D7, Igloo A.

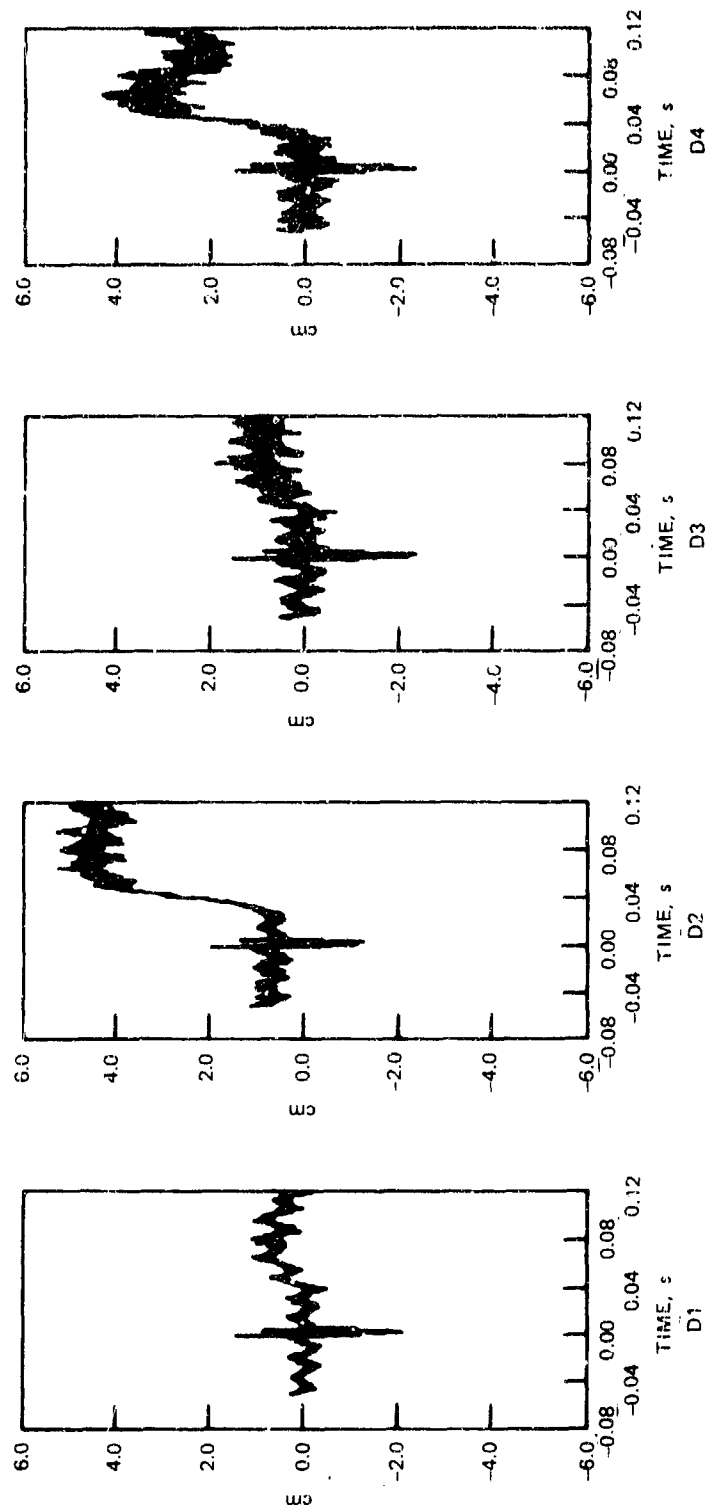
FIGURE 52. Data Plots for Deflection Gauges D1, D2, D3, and D4, Igloo B.

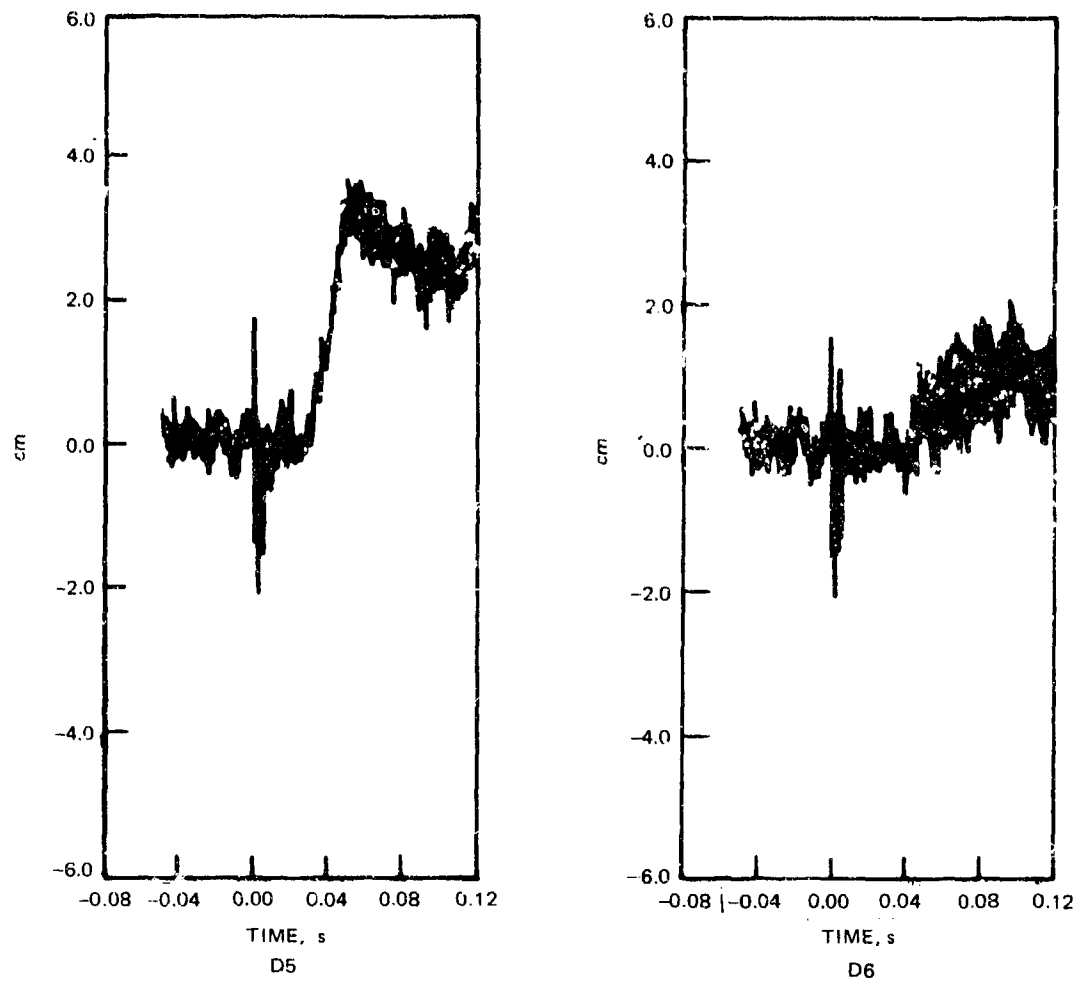
FIGURE 53. Data Plots for Deflection Gauges D5 and D6, Igloo B.

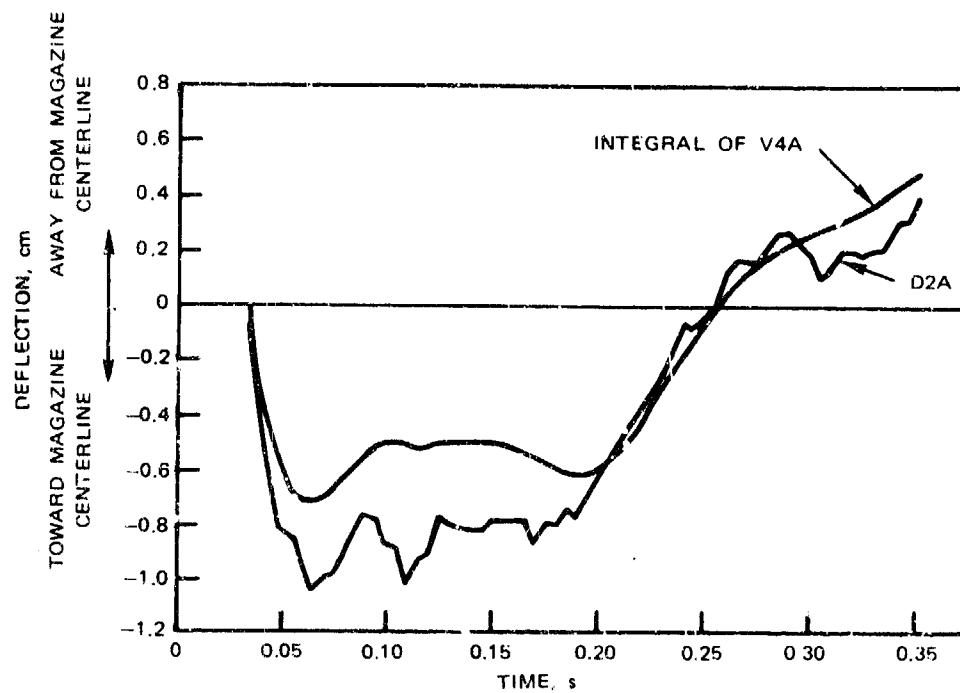
FIGURE 54. Comparison Between Sidewall Deflection Gauge D2 and Integral of Velocity Gauge V4 Located on Donor Side, 40 Feet From Headwall, FRELOC Igloo A.

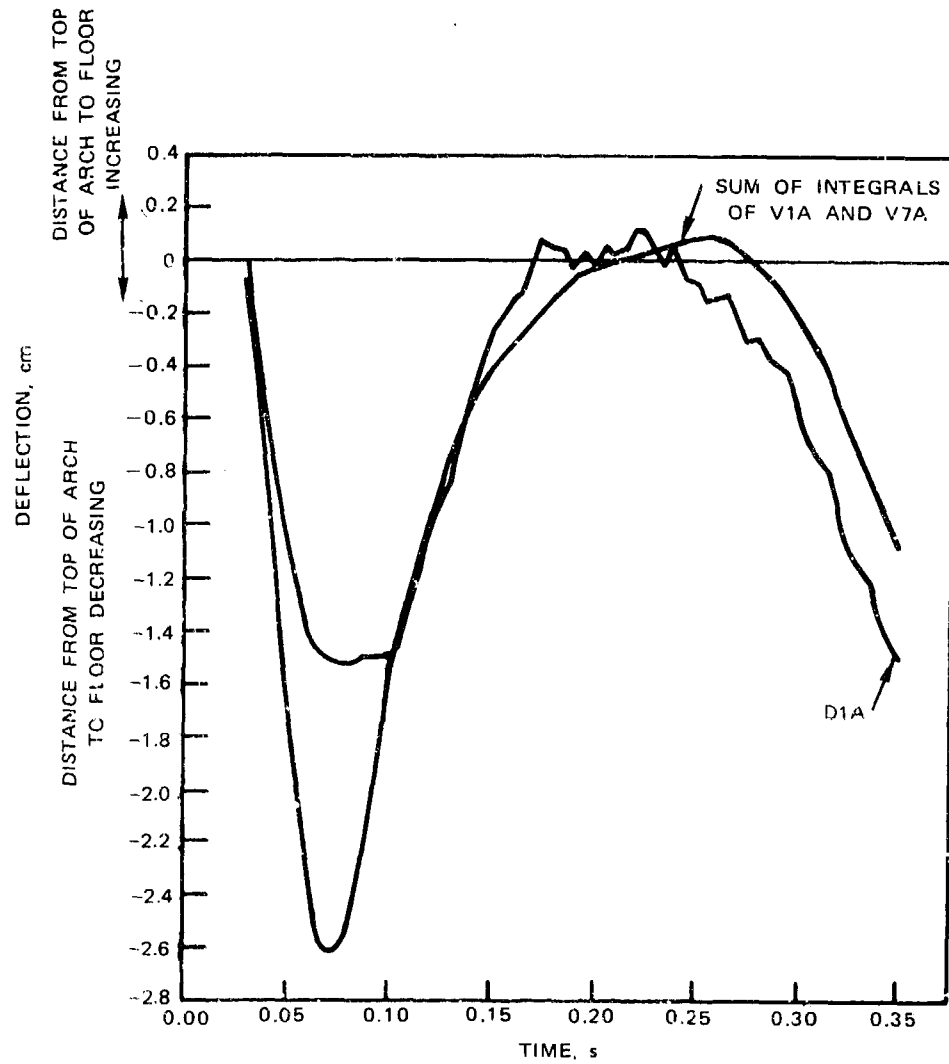
FIGURE 55. Comparison Between Arch/Floor Deflection Gauge D1 and the Sum of the Integrals of Velocity Gauges V1 and V7 Located 40 Feet From Headwall, FRELOC Igloo A.

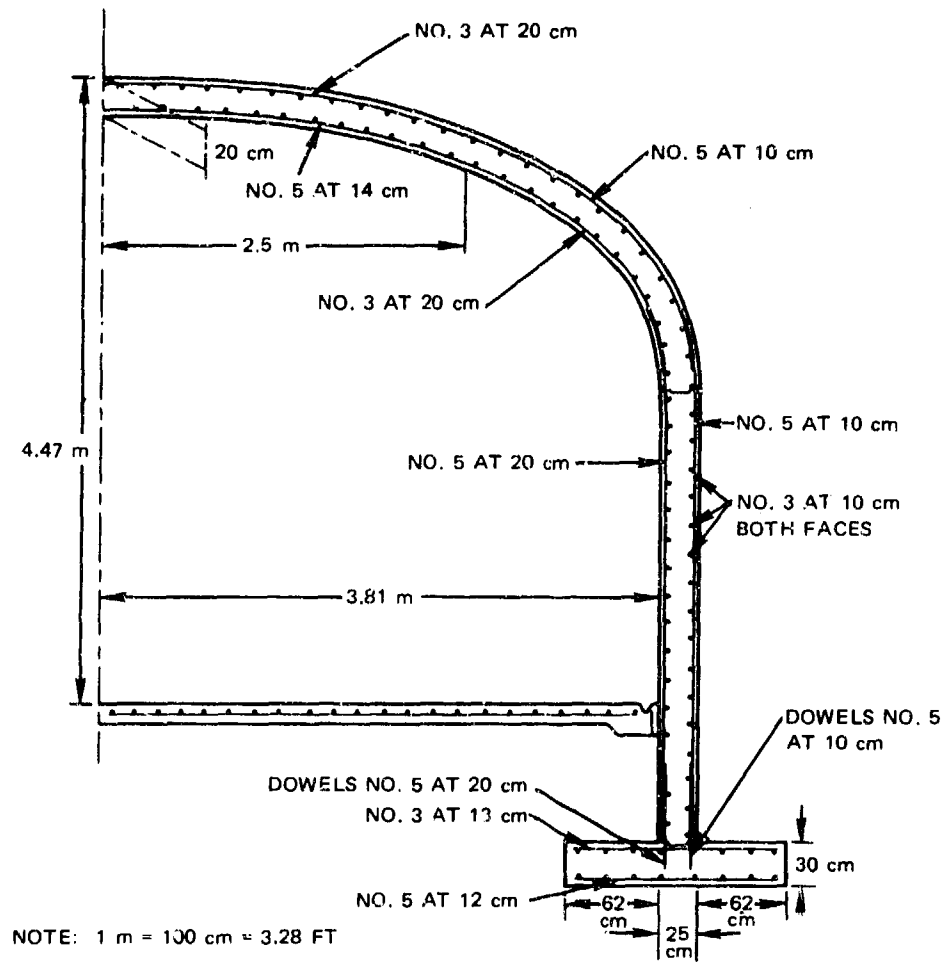
FIGURE A-1. Half-Section of Test Structure.

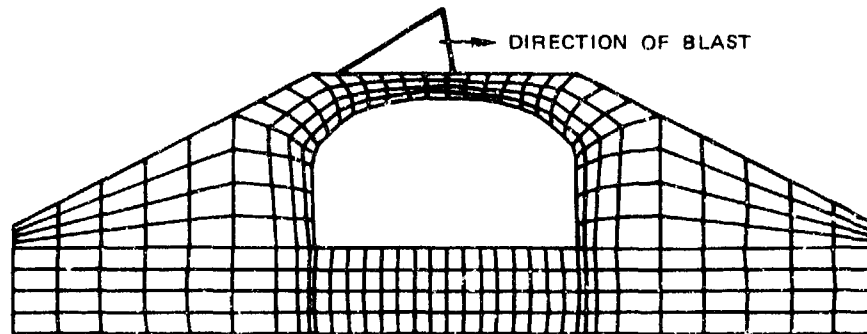
FIGURE A-2. Finite Element Model of Structure and Earth Mound.

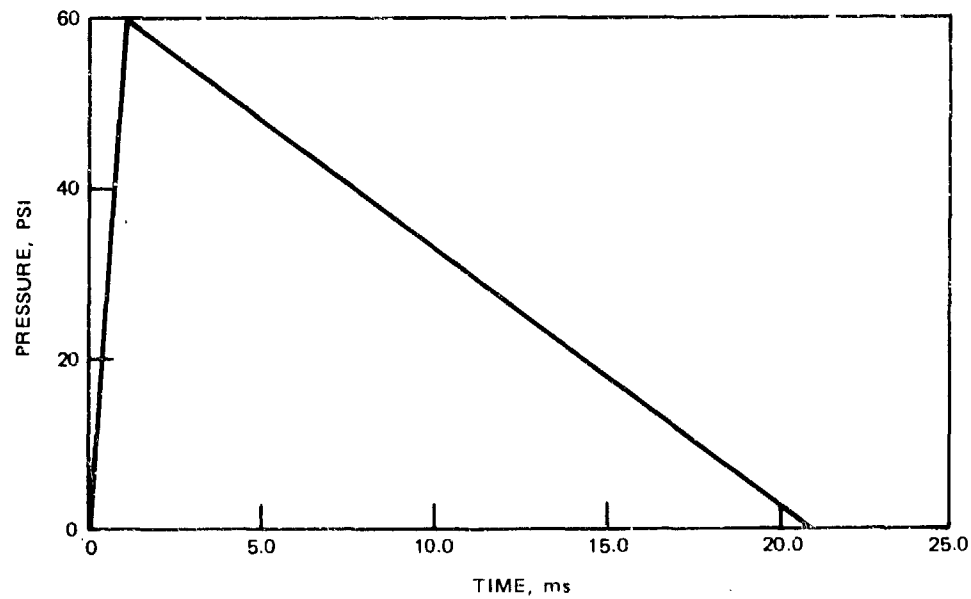
FIGURE A-3. Idealized Incident Wave.

The incident traveling overpressure wave (Figure A-3) was an idealization of the average measured wave forms on Igloos A and B in Reference 1. The wave travels across the structure at approximately the same speed as the measured overpressure pulse in the previous tests. Thus, the loading function is a realistic approximation of actual test conditions.

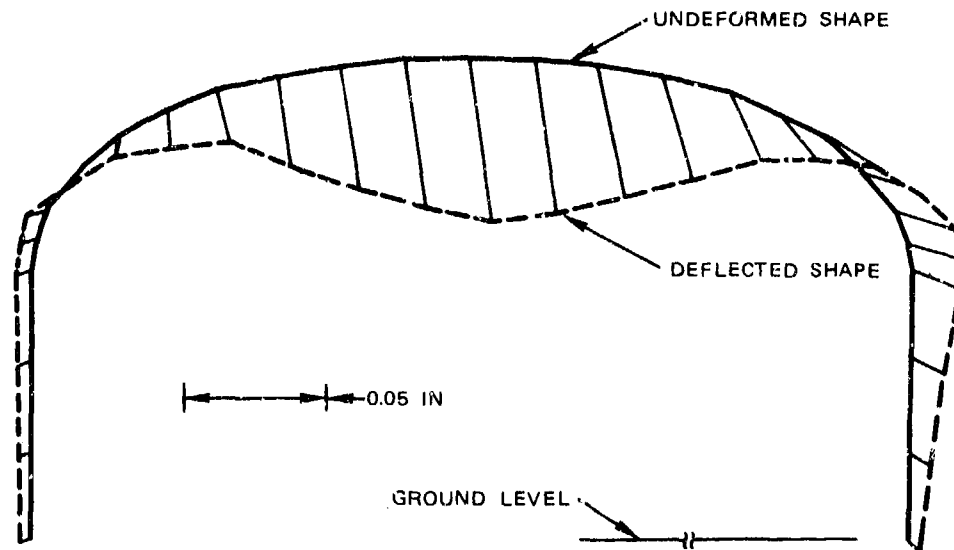
FIGURE A-4. Deflected Slope of Igloo.

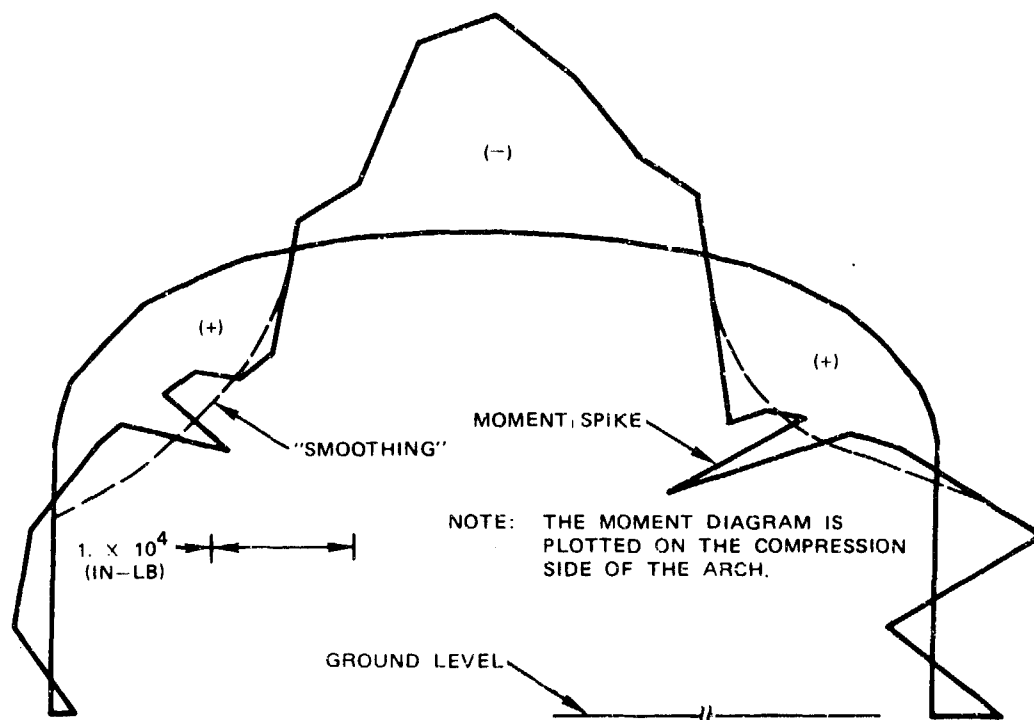
FIGURE A-5. Moment Diagram of Maximum Response
